A Holistic Evaluation of a Typical Coast Nourishment on the Danish West Coast

Journal of Coastal Conservation

A holistic evaluation of a typical coast nourishment on the Danish West Coast

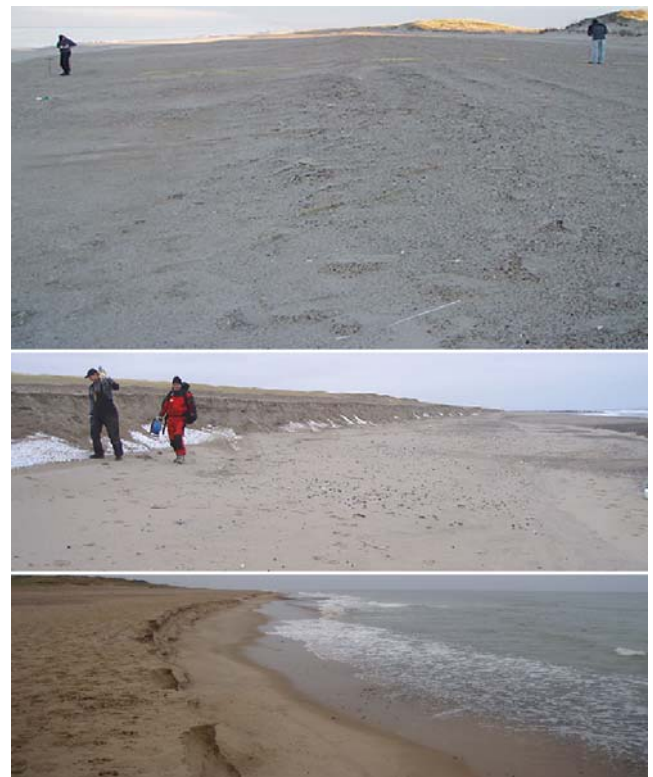
Fig. 6 Beach development: gentle slope leading to the shore generates in a dangerous and undesirable scarp for recreational beach visitors

Figure 6 gives examples of the development of the coast nourishment at Ferring. The top photo shows a nice gentle slope beach with characteristics as wanted, while the two other photos show an example of the unwanted scarp and progressing degradation of the beach.

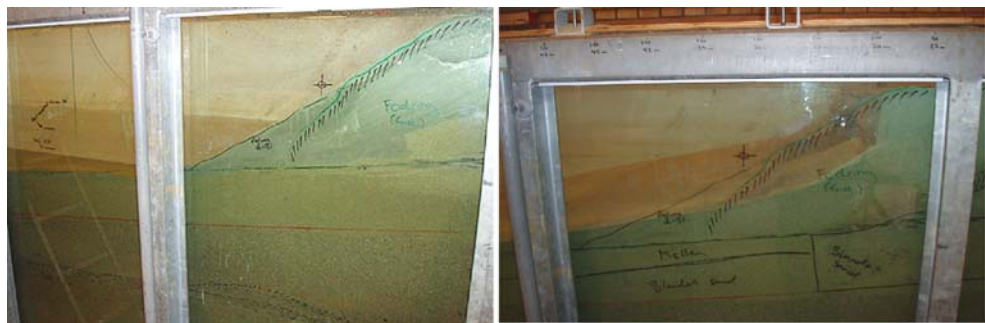
Fig. 11 Profile of the beach before (*left*) and after (*right*) the test (Holmgren et al. 2006a, b)

Measurements have been done at the beginning and at the end of each test (Fig. 11). A laser profiler mounted on rails on the flume enabled the estimation of the damage to the protection (Fig. 12, left). The laser profiler can plot the results of the profile measurements in real time and constitutes a user friendly interface with the EPro software (AAU 2004b). In a second time it is possible to calculate the damage in terms of lost volumes to the protection (Fig. 12, right). Waves have been measured by wave gauges and generated by AwaSys 5 (AAU 2004a).
